The Development and Flight Testing of the XC-8A Air Cushion Landing System (ACLS)

David J. Perez

Air Force Flight Dynamics Lab., Wright-Patterson Air Force Base

760920

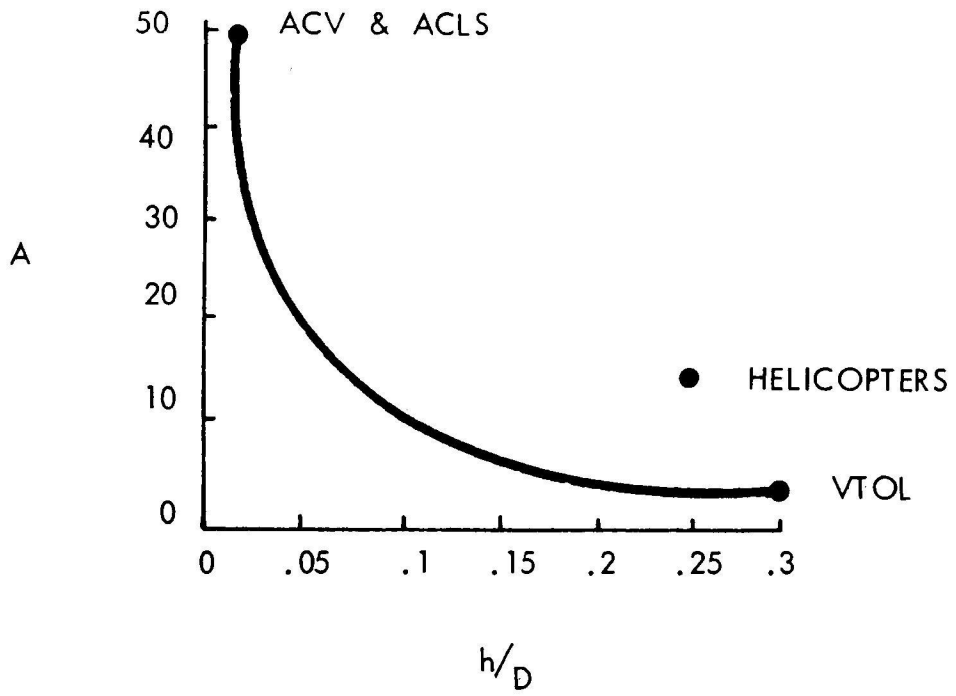
Figure 3 graphically illustrates the augmentation or lift efficiency of a thin annular jet plotted against variations in daylight clearance and planform diameter. The lifting power of a typical ACV and ACLS is about 50#/hp (0.03 Kg/w) as compared to 12#/hp (0.0073 Kg/w) and 4#/hp (0.0024 Kg/w) for a typical helicopter and tilt wing VTOL in ground effect hover.

Fig. 3 - Lift augmentation factor

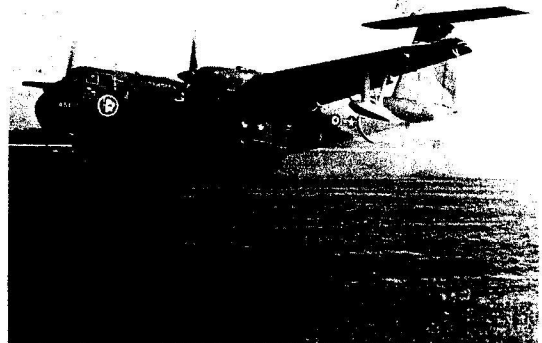
Fig. 5 - XC-8A landing on a grass runway

As a result of the successful LA-4 tests, the USAF and the Canadian Government initiated a joint cooperative development project in May 1971 to demonstrate the functional capabilities of an ACLS equipped de Havilland Buffalo aircraft (Figure 5). The individual work efforts performed during this program were assigned to four contractors: Bell Aero-

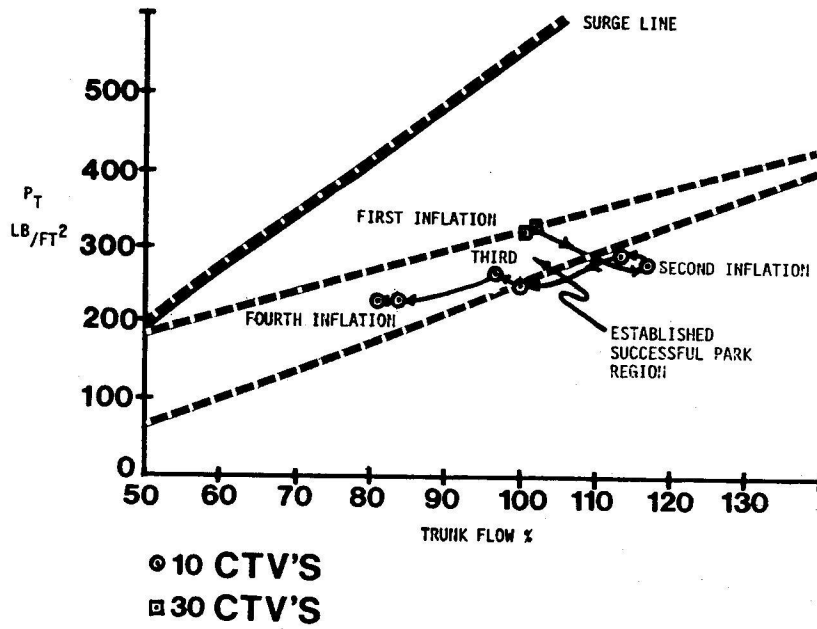
Fig. 20 - Typical park sequence

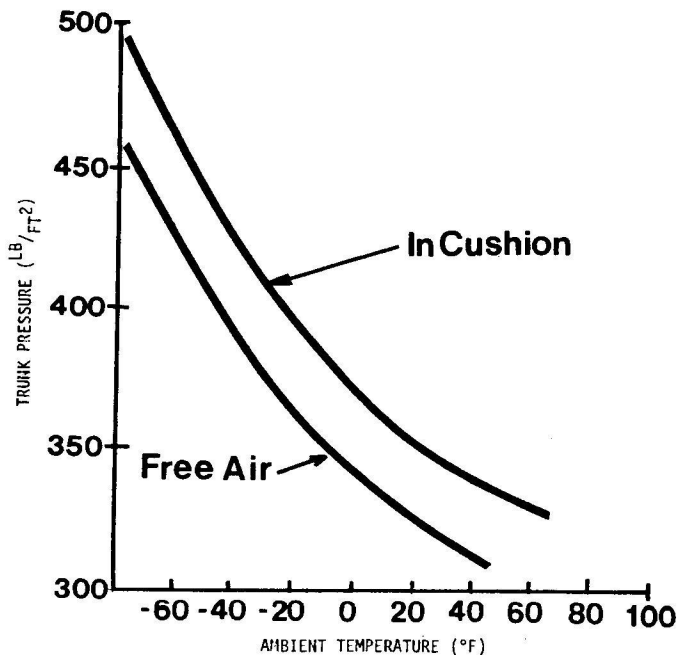
Fig. 31 - Trunk operating pressure vs ambient temperature
